# Manhole Inspection Summary

Manhole # S21MM\_012MH

Insp Date: **6/29/07 10:41 AM**

**Location** Address: **2201 FULTON AVE**

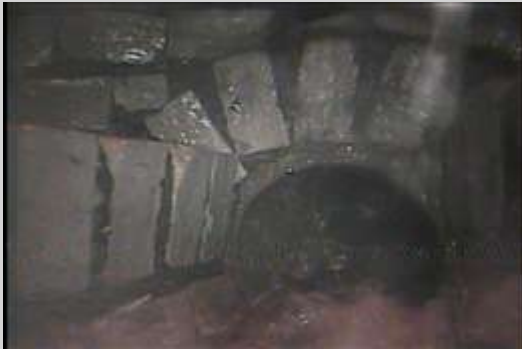
12 O'Clock Outflow

10 in. Circular Gravity Sewer  
Pipe Out @ 12 O'Clock

Pipe Height: **8.4** (in.) Rod and Bar (Angled)  
Pipe Material: **Clay** ☐ Pipe Lined  
Invert Depth: **13.11** (ft.) Flow Characteristics: **Fast**  
Deposits: ☒ None ☐ Mud ☐ Sludge ☐ Debris ☐ Grease  
Silt Depth: (in.) Deposits Extent:  
Infiltration: **None** Pipe Seal Cond: **Sound**

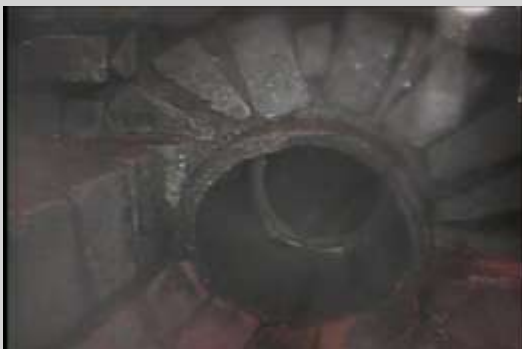
4 O'Clock Inflow

8 in. Circular Gravity Sewer  
Pipe In @ 4 O'Clock

Pipe Height: **8.4** (in.) Rod and Bar (Angled)  
Pipe Material: **Clay** ☐ Pipe Lined  
Invert Depth: **12.35** (ft.) Flow Characteristics: **Slow**  
Deposits: ☒ None ☐ Mud ☐ Sludge ☐ Debris ☐ Grease  
Silt Depth: (in.) Deposits Extent:  
Infiltration: **None** Pipe Seal Cond: **Sound**
